HOVMAND
LIFTING & MOVING TECHNOLOGY

Impact 70-80-130-200-INOX 200

Checking top limit switch.

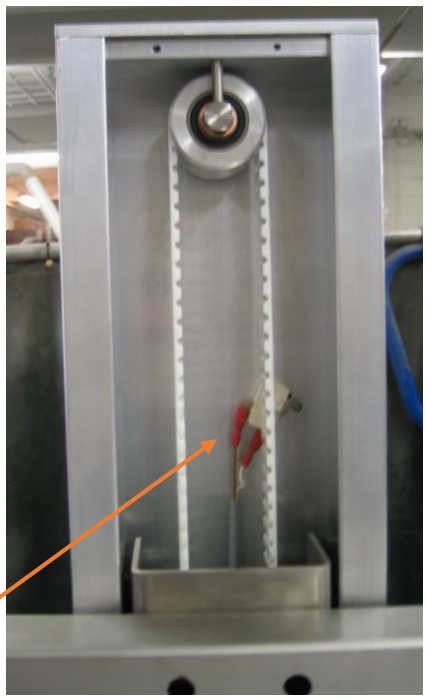
Impact 130

Top limit switch is located approx. 20 cm from the top.

Remove front cover. Take off 4-5 screws. Lift off the cover.

If UP don't work it is most likely a failure at the contact arm of the top limit switch. Test the switch by putting a wire across the top limit switch connections. Press UP button and if it works you can replace the top limit switch using a hexagon key 2,5mm. Make sure the wires are connected to the NC pins 1 & 4. Contact arm with roller shall be mounted in the middle position.
